Manhole Inspection Summary

Manhole # S15A1_008MH

Insp Date: **6/30/08 11:00 AM**

Location Address: **2831 georgetown rd**

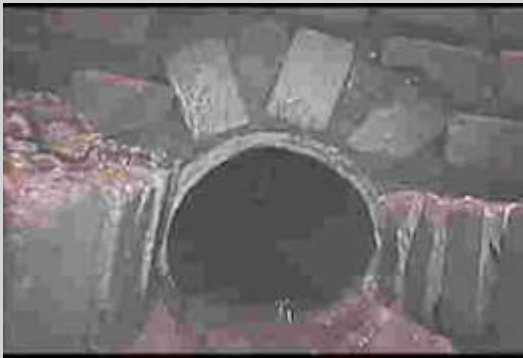
12 O'Clock Outflow

8 in. Circular Gravity Sewer
Pipe Out @ 12 O'Clock

Pipe Height: **8.4** (in.) Rod and Bar (Angled)
Pipe Material: **Clay** ☐ Pipe Lined
Invert Depth: **11.60** (ft.) Flow Characteristics: **Fast**
Deposits: ☒ None ☐ Mud ☐ Sludge ☐ Debris ☐ Grease
Silt Depth: **0** (in.) Deposits Extent:
Infiltration: **None** Pipe Seal Cond: **Sound**

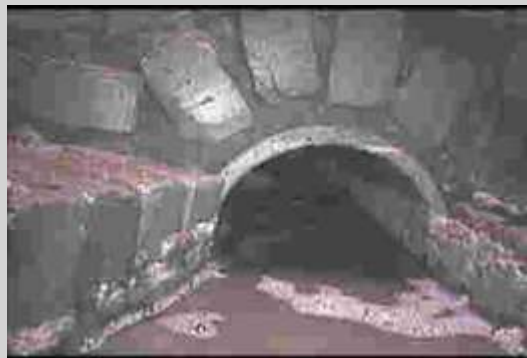
9 O'Clock Inflow

8 in. Circular Gravity Sewer

Pipe In @ 9 O'Clock

Pipe Height: **8.4** (in.) Rod and Bar (Angled)

Pipe Material: **Clay** ☐ Pipe Lined

Infiltration: **None** Pipe Seal Cond: **Sound**
